CONTRACT NO: HY/2019/14
NEW WANG TONG RIVER BRIDGE
BASELINE MONITORING REPORT

Highways Department

Lam Environmental Services Limited

24 May 2021

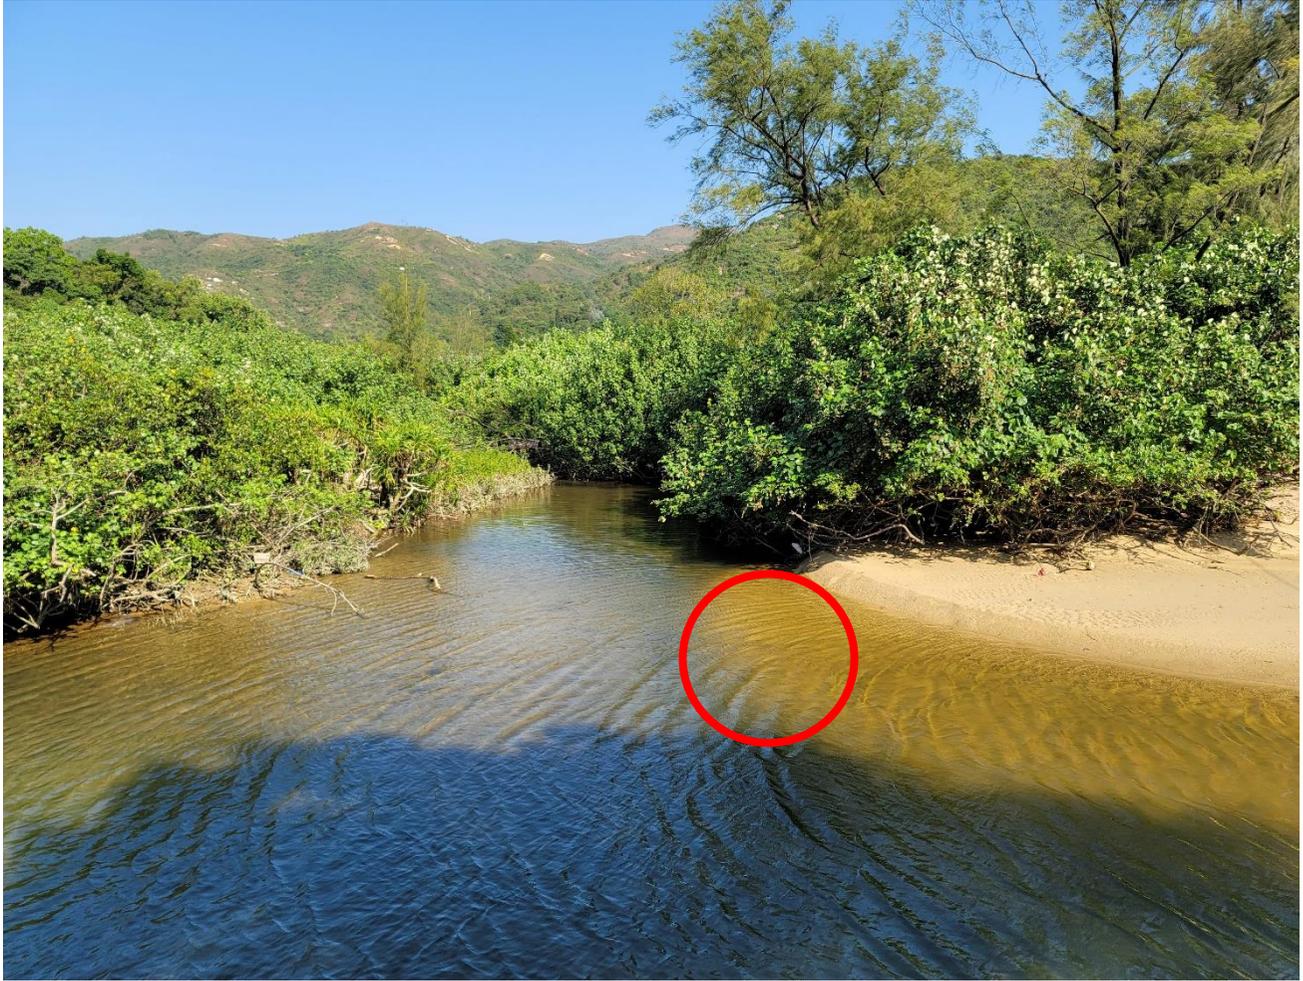
Monitoring Station	Description	Monitoring Location
W5	Silvermine Bay (Near Silvermine Bay Beach)

A photograph of the Wang Tong River. The river flows from the background towards the foreground. The water is a mix of brown and blue. On the right side, there is a sandy bank with dense green vegetation. A red circle is drawn around a specific area in the water near the bank, likely indicating a monitoring point. The background shows green hills under a clear blue sky.

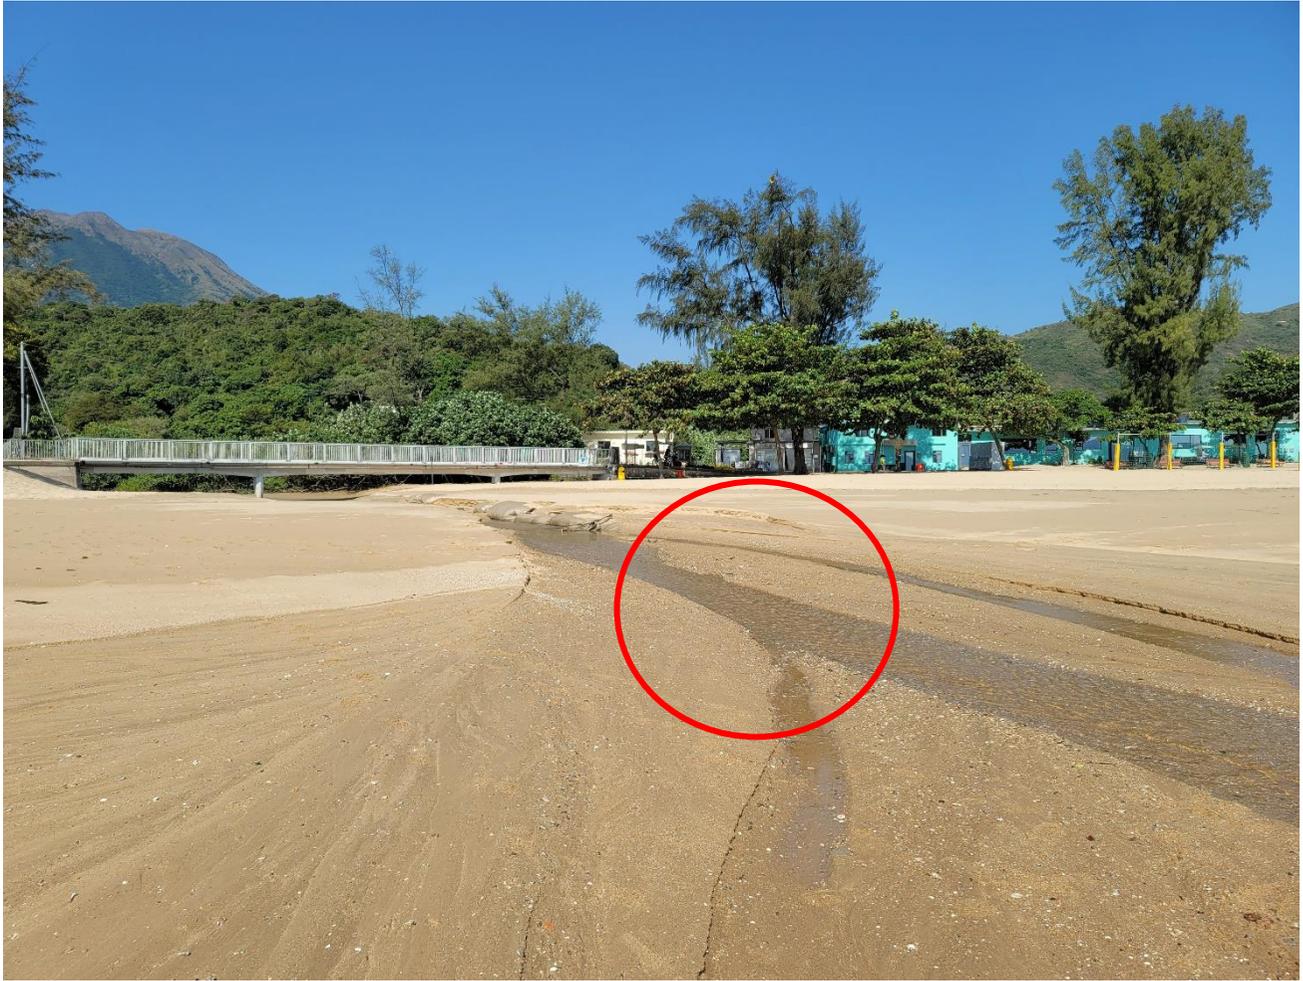
Monitoring Station	Description	Monitoring Location
W6	Silvermine Bay (Near Silvermine Bay Beach)

A wide-angle photograph of a sandy beach area. In the foreground, there is a large, flat expanse of light-colored sand. A red circle is drawn on the sand, highlighting a specific spot. In the middle ground, there is a concrete walkway or ramp with a metal railing. Behind the railing, there are several trees and a building with a blue roof. In the background, there are green hills and a large mountain peak under a clear blue sky.

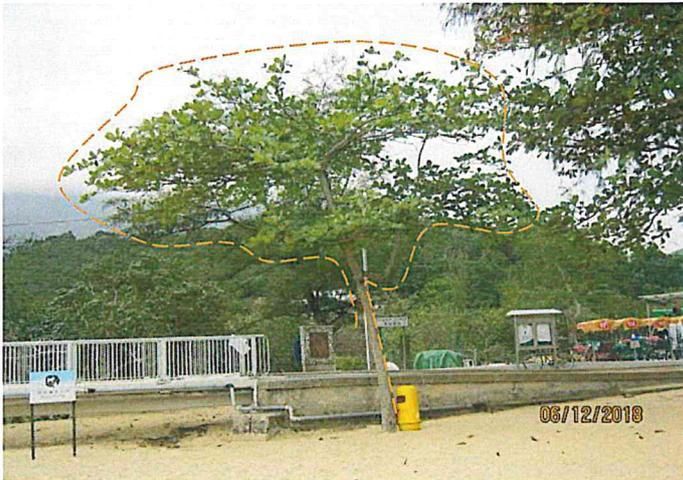
General View

co-dominant leaders / wounds found at the branches and leader.

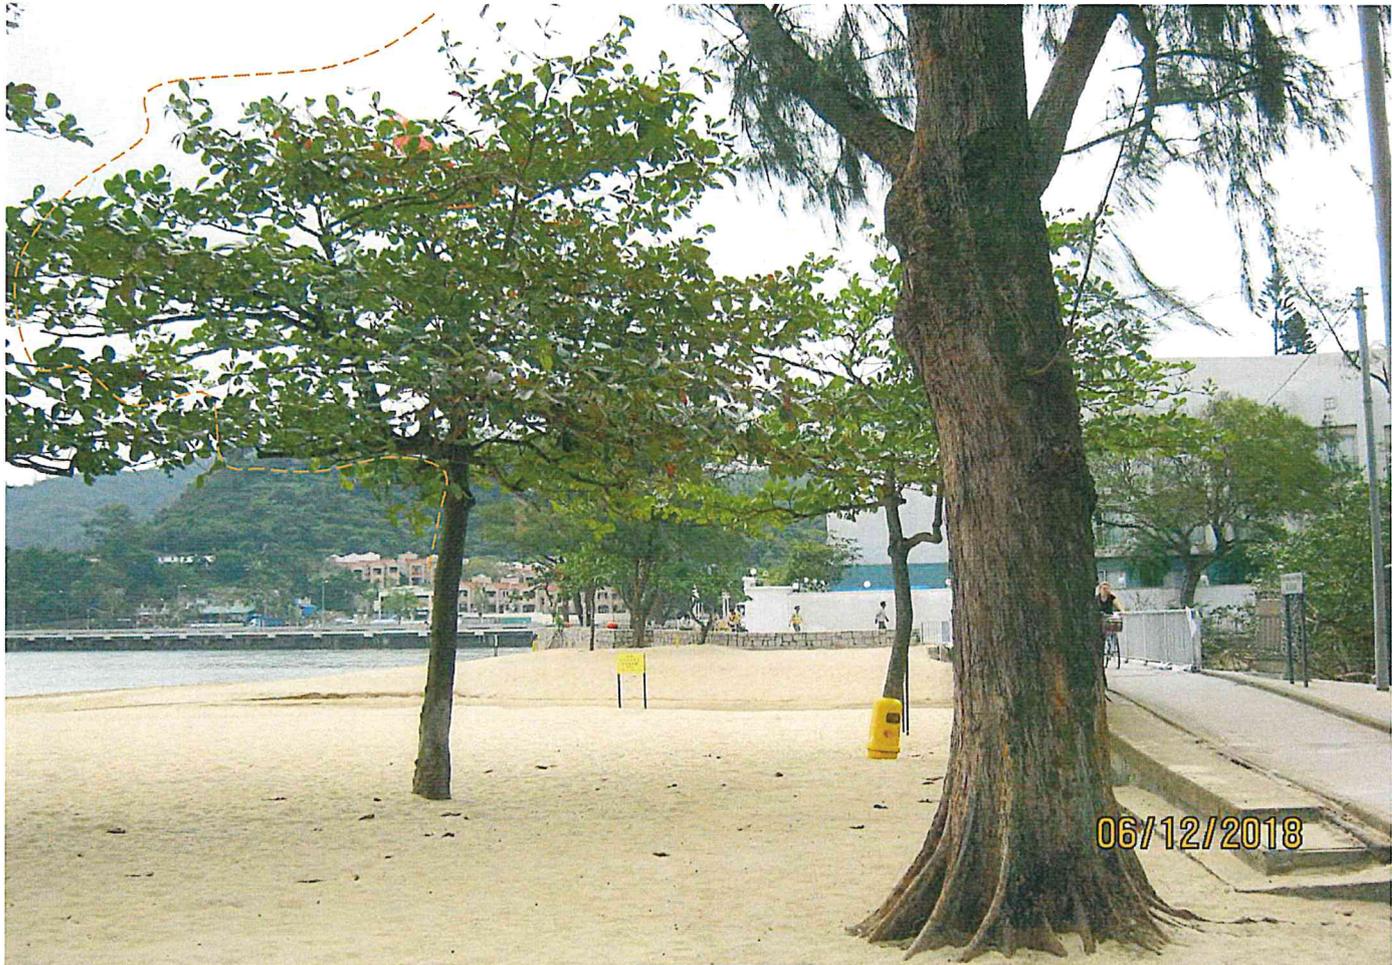
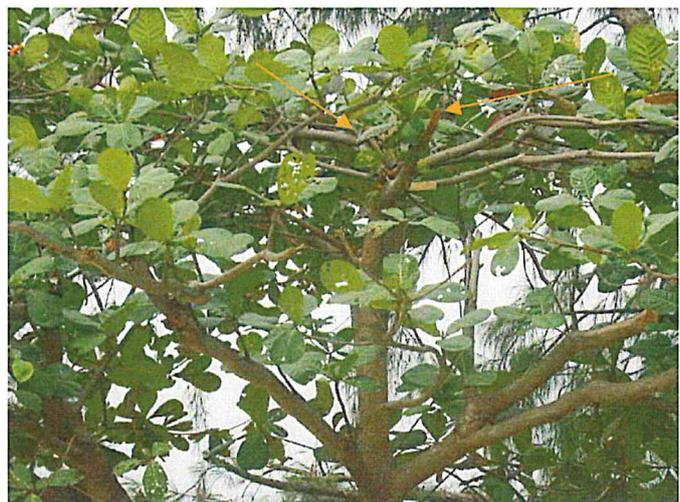
co-dominant leaders / broken branches at the tree top.

General View (Co-dominant leaders)

broken branches at tree top

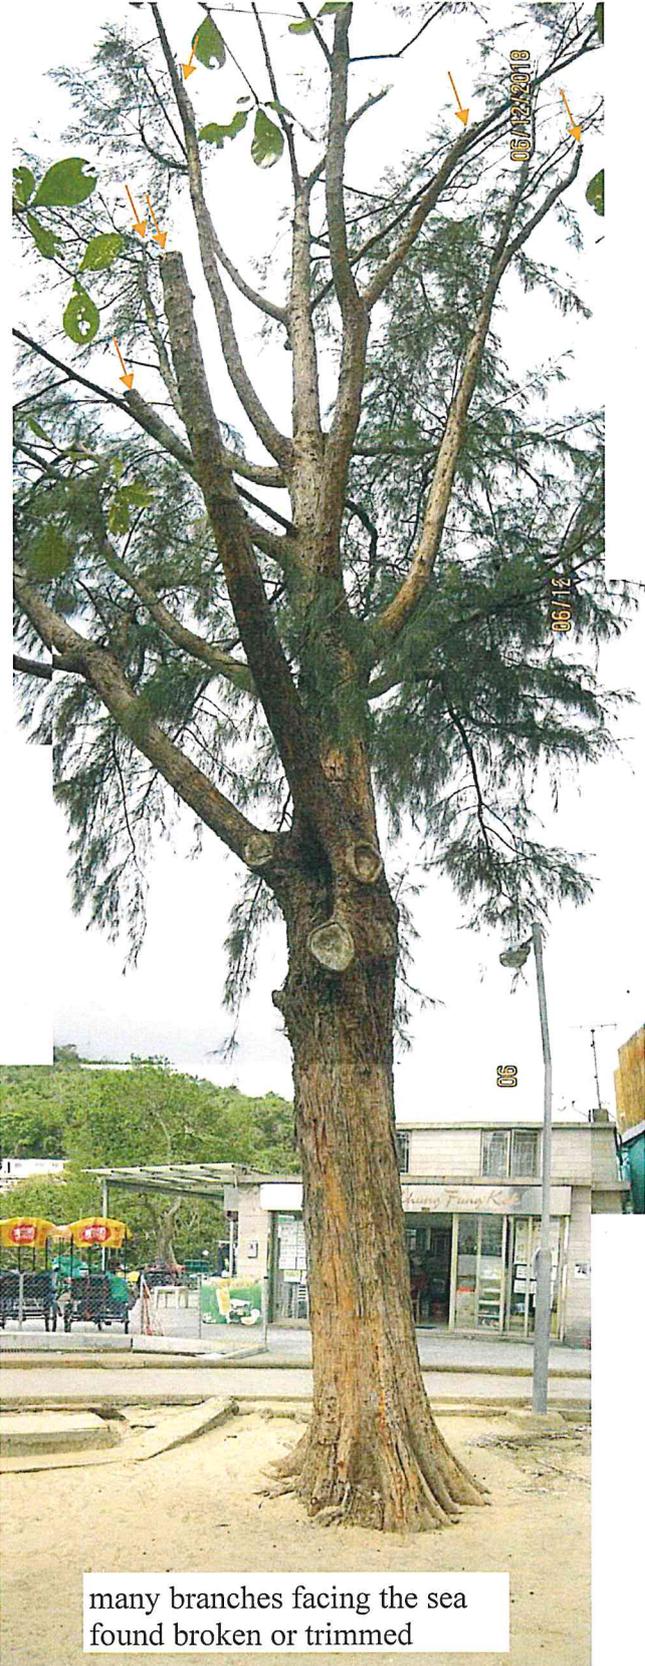
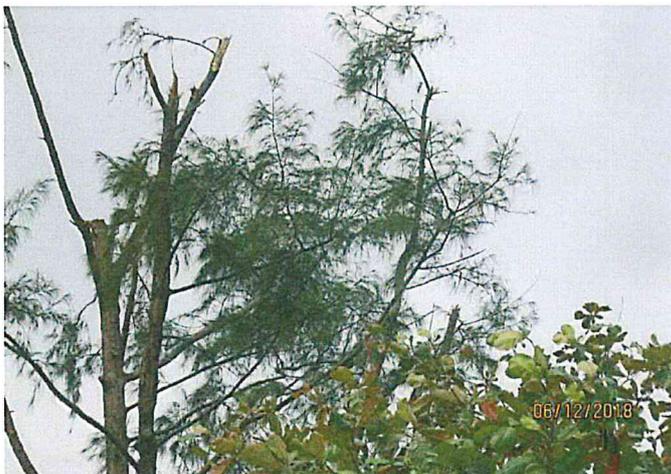
General View

Many branches facing the sea found broken or trimmed / a few branches at the tree top found broken or trimmed.

the branches at the tree top found broken or trimmed

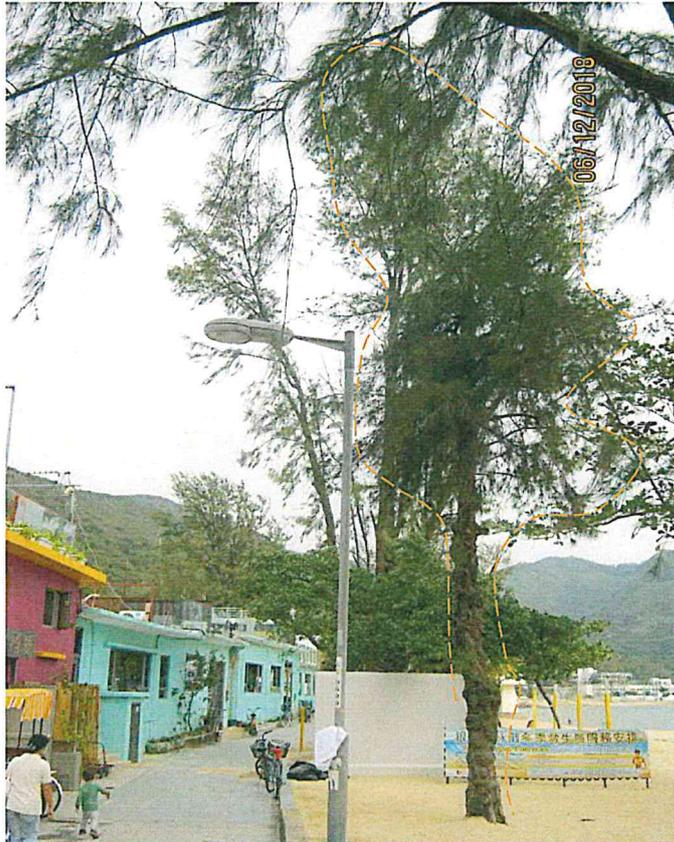
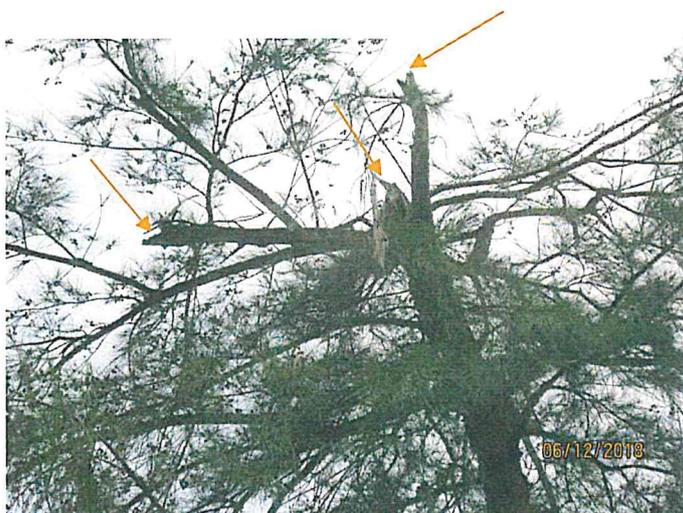
General View

Unbalanced crown / a few broken branches at the tree top / many bulges along the trunk.

broken branches at the tree top

many bulges along the trunk

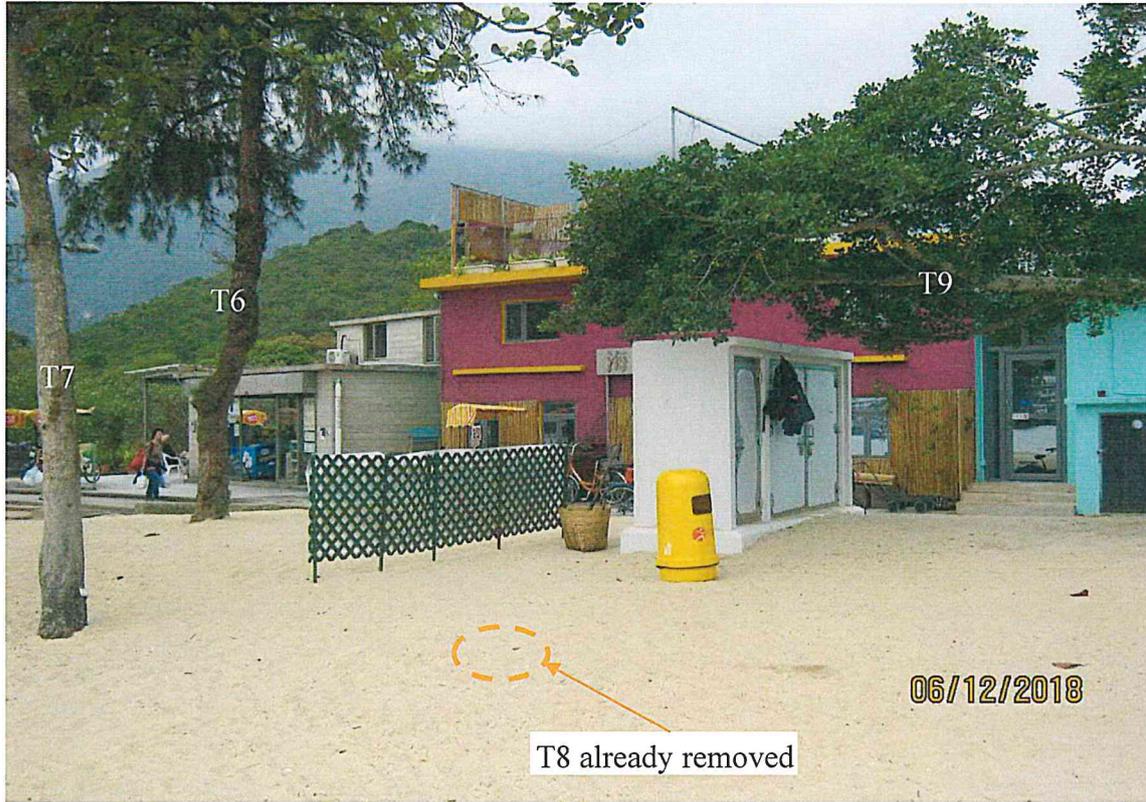
Tree No. T8 - Unknown species (Removed)

T8 was found already removed.

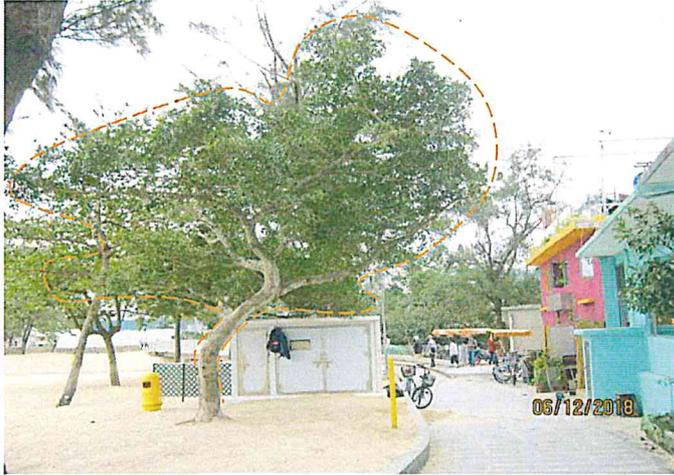
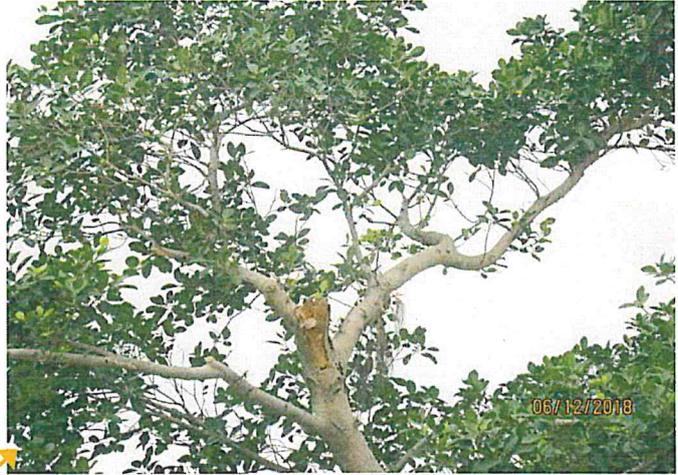
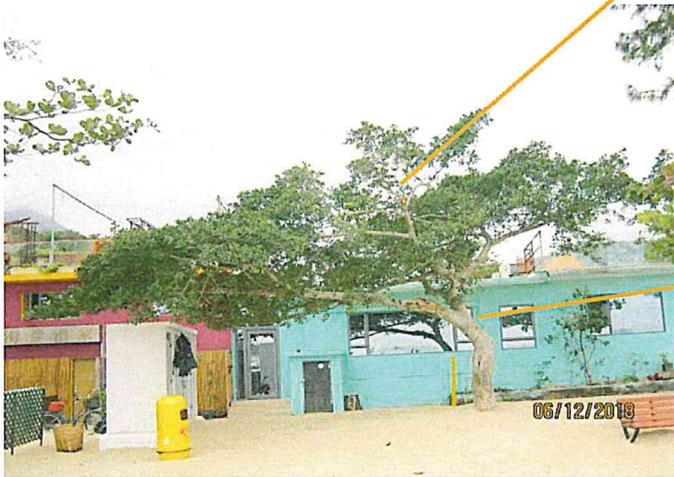
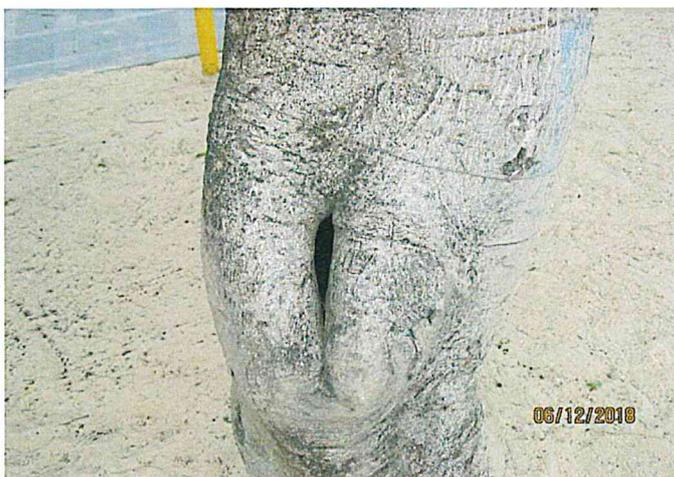
General View

Leaning form / broken wound at the co-dominant leader / trunk cavity.

broken wound

leaning form

broken wound at the co-dominant leader

trunk cavity

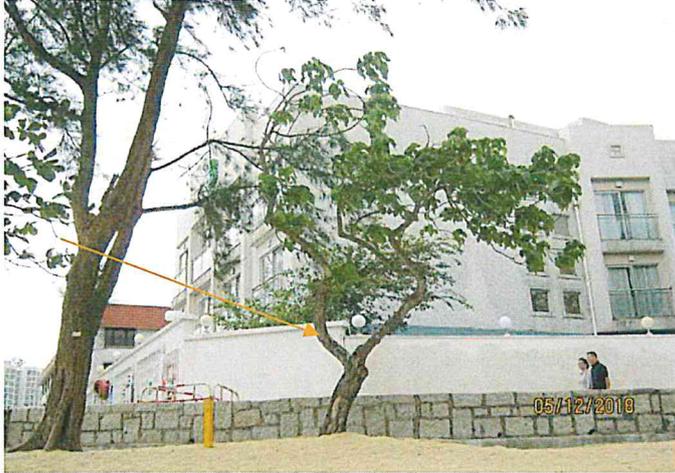
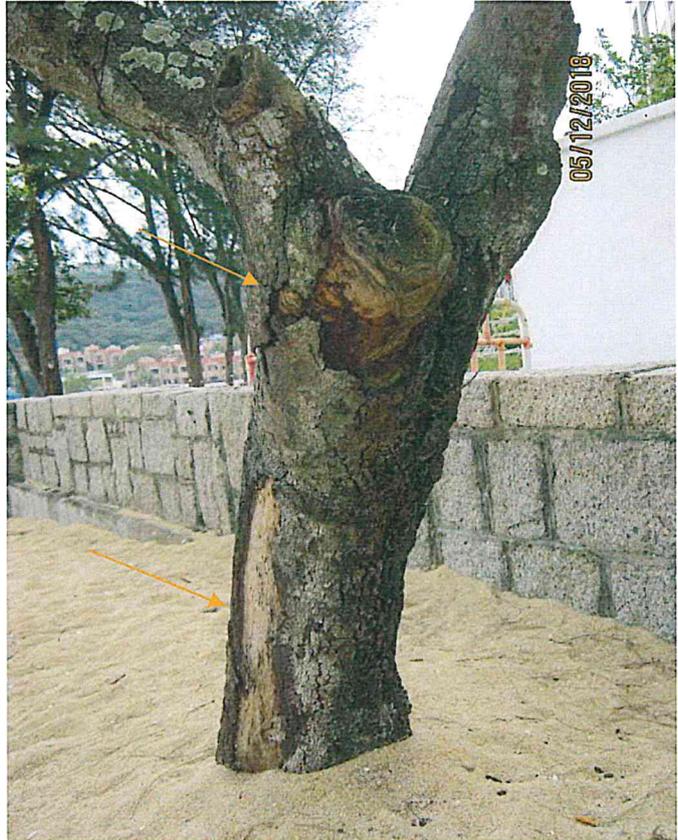
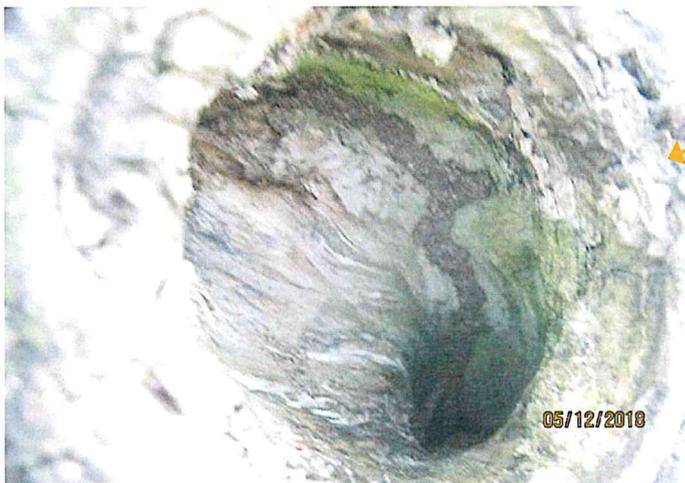
General View (co-dominant stems)

co-dominant stems / 2 spots of decay at the crotch / basal decay / one stem with cavity & mud tube.

a spot of decay at the crotch & basal part

another spot of decay at the crotch

mud tube inside the cavity

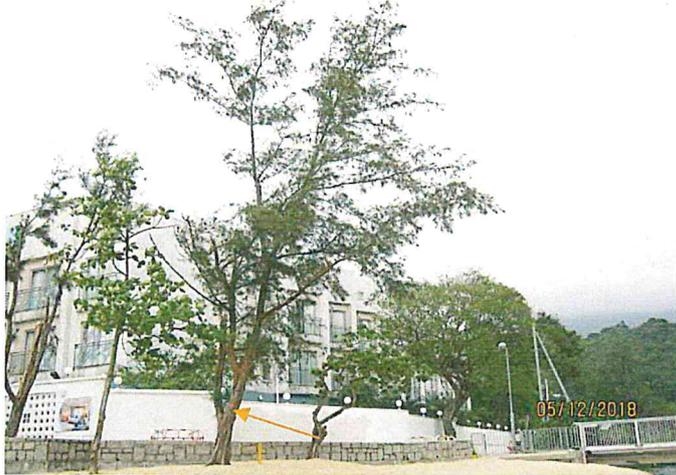
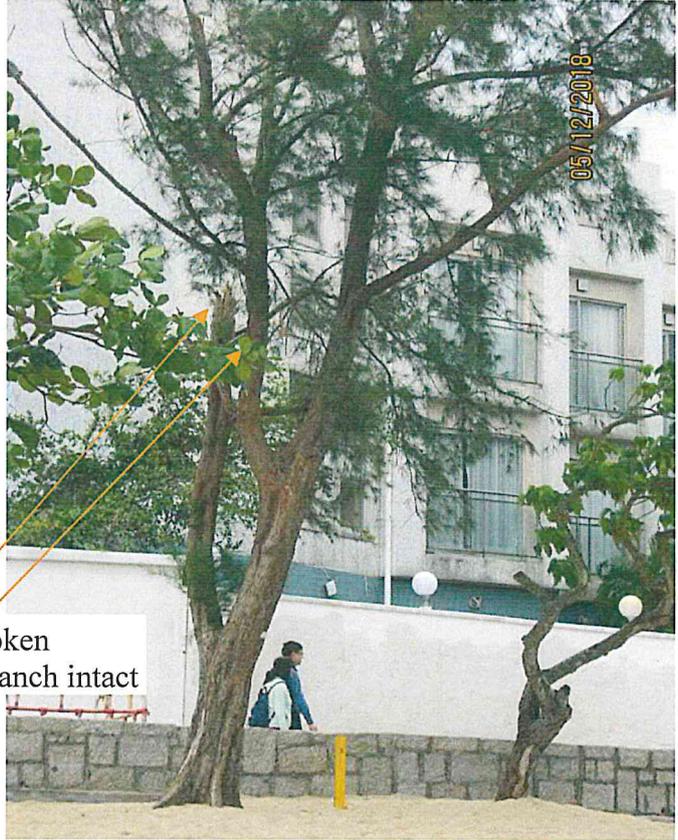
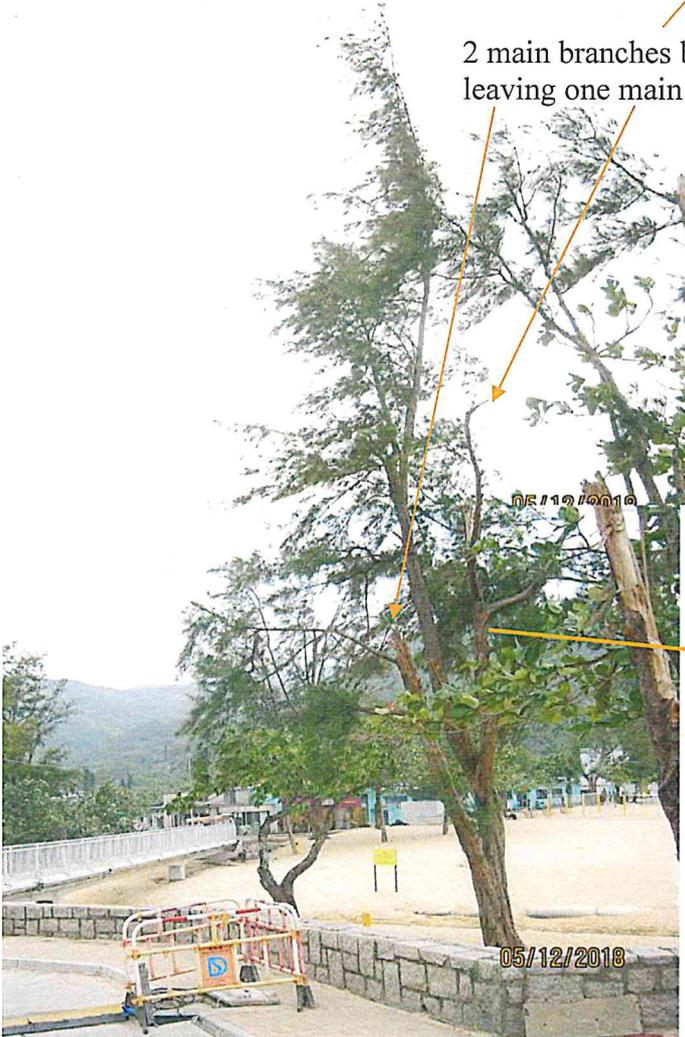
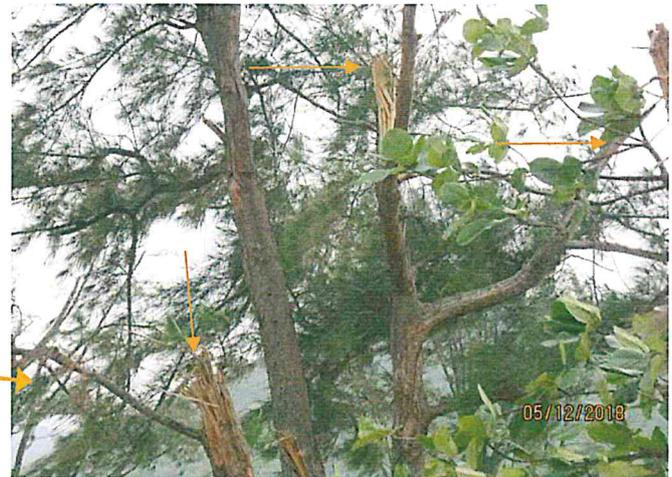
General View

2 of the 3 main branches found broken / a wound on the trunk.

2 main branches broken
leaving one main branch intact

wound on trunk

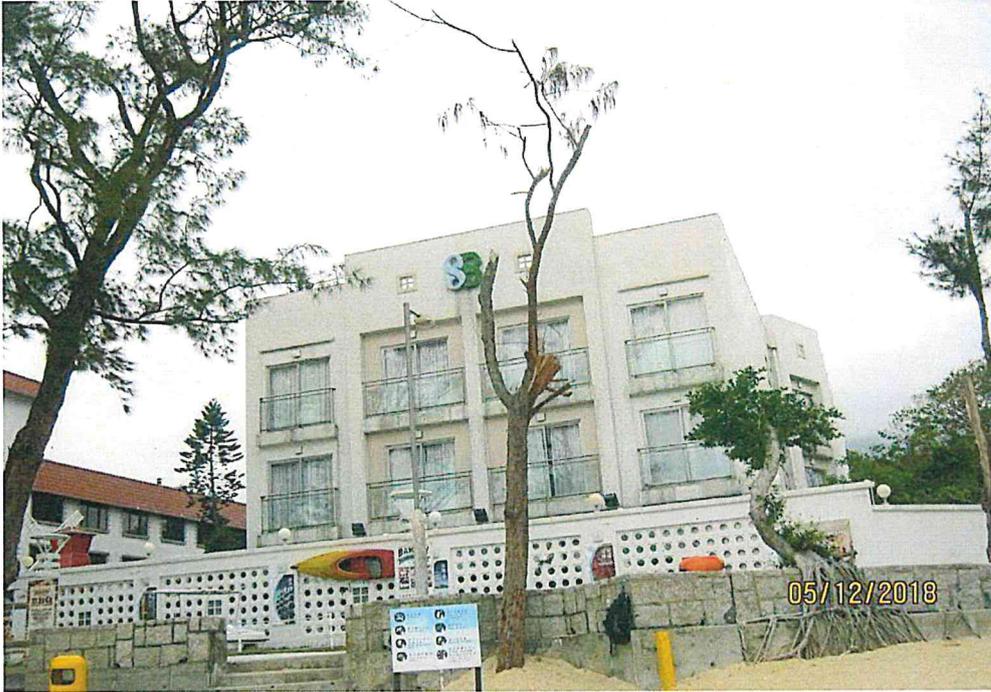
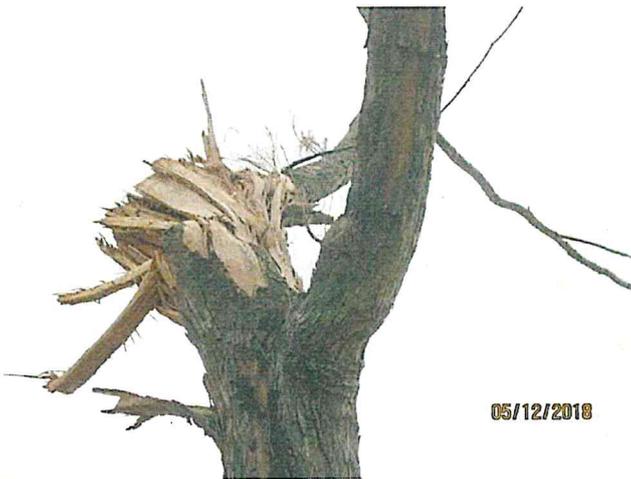
General View

The main branches found broken and the remaining branch attaching to the broken wound.

The main branches found broken and the remaining branch attaching to the broken wound

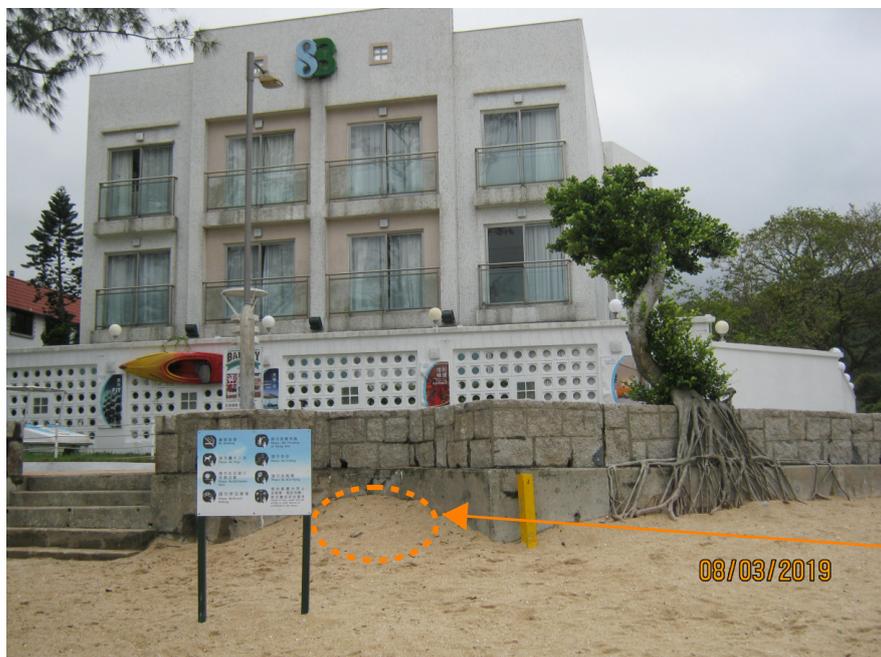
General View

The tree was found removed.

T34 already removed

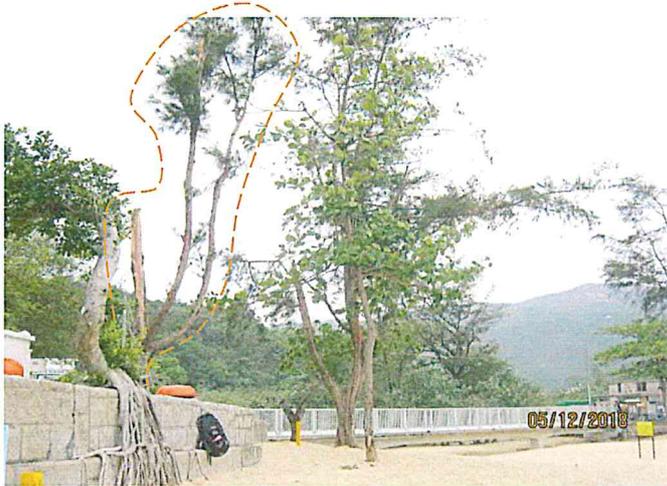
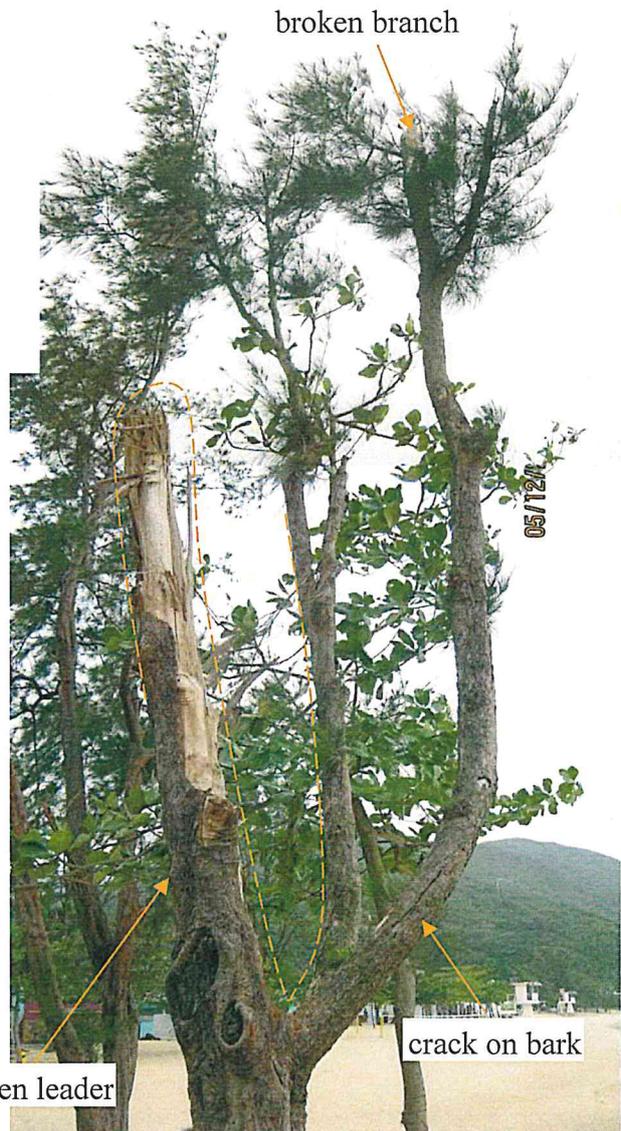
General View

leader broken / one branch with crack on bark / a broken branch.

some wounds on trunk

broken leader

crack on bark

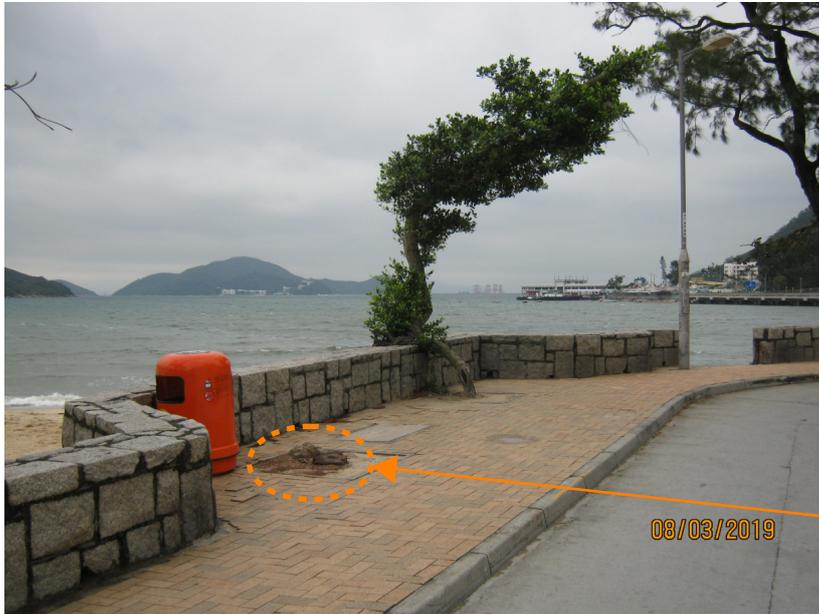
Tree No. T35 - *Casuarina equisetifolia* 木麻黃

Observations & Remarks :
The tree was found removed.

T35 already removed

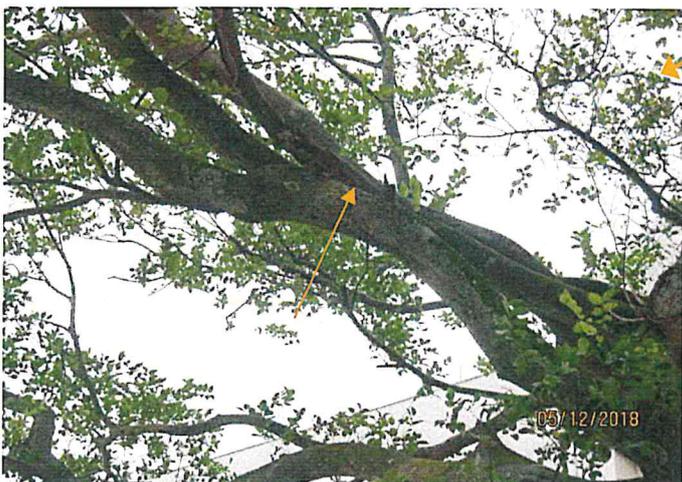
hanger found

crossed branches

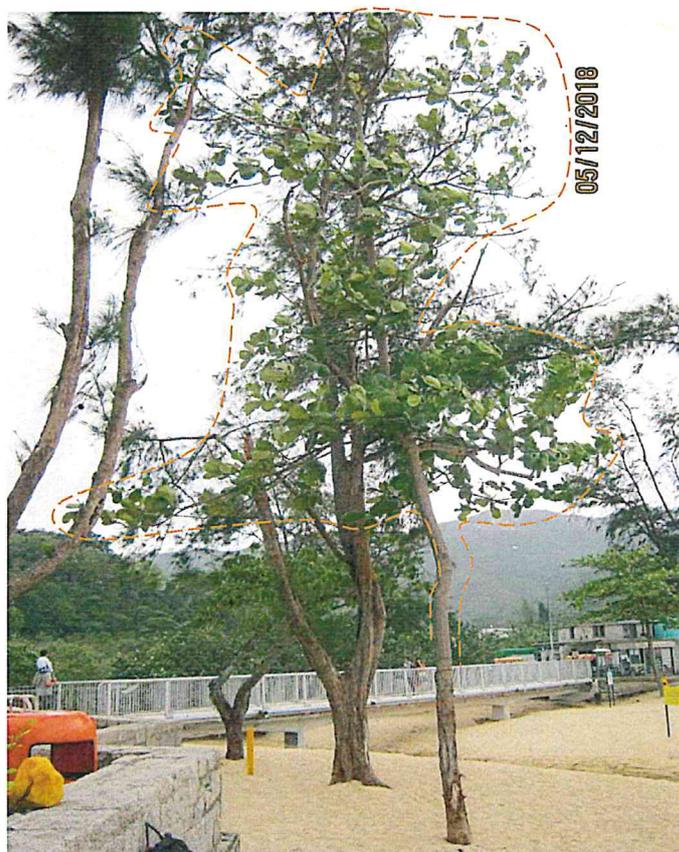
General View

2 wounds found on lower trunk.

2 wounds found on lower trunk

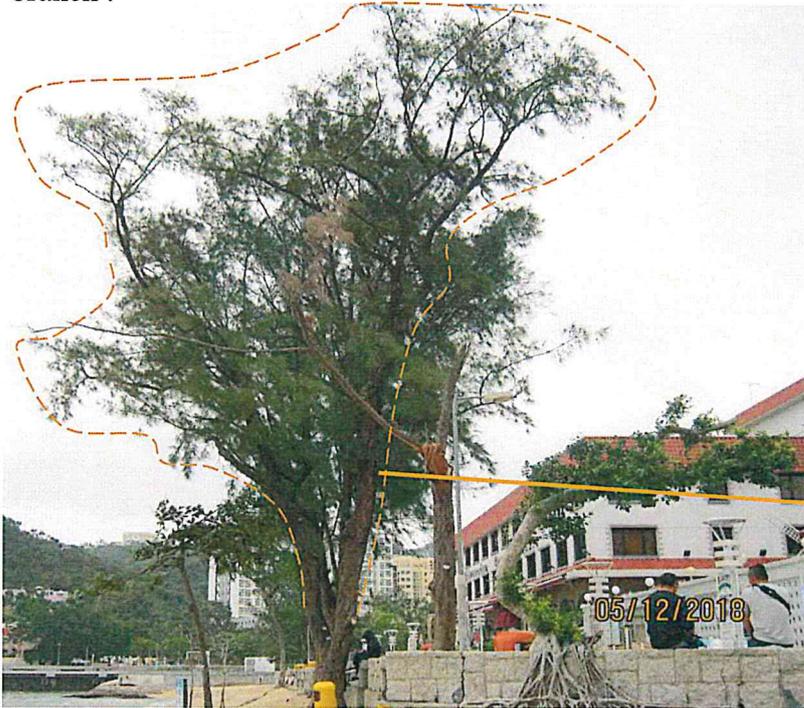
General View

Co-dominant leaders / wounds along main branches / wounds at the root collar / a broken branch .

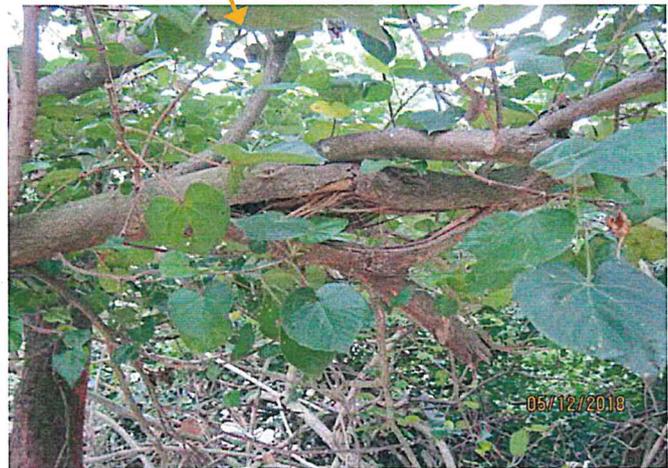
General View (poor form)

the tree in poor form / the leader cracked / wound at the trunk.

wound at the trunk

leader cracked

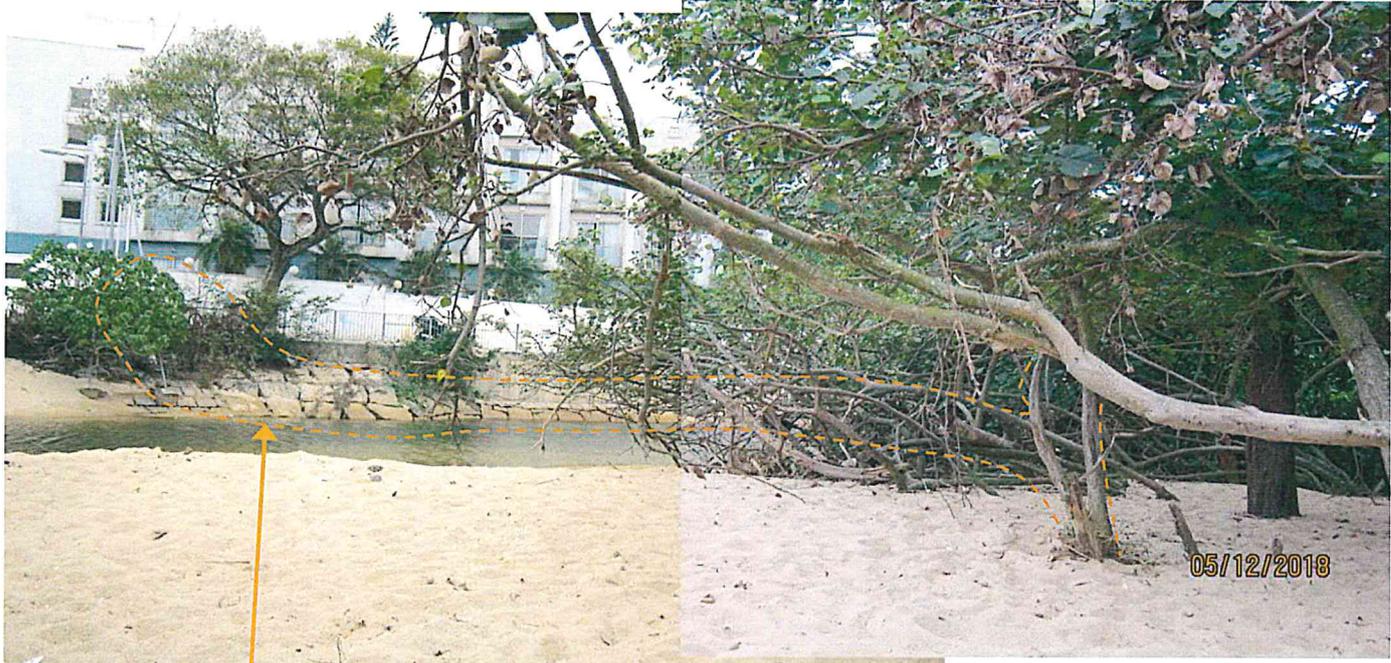
General View (one of the multiple attachments was broken)

Multiple attachments - one stem found broken and the other 2 in leaning form.

Original view of tree

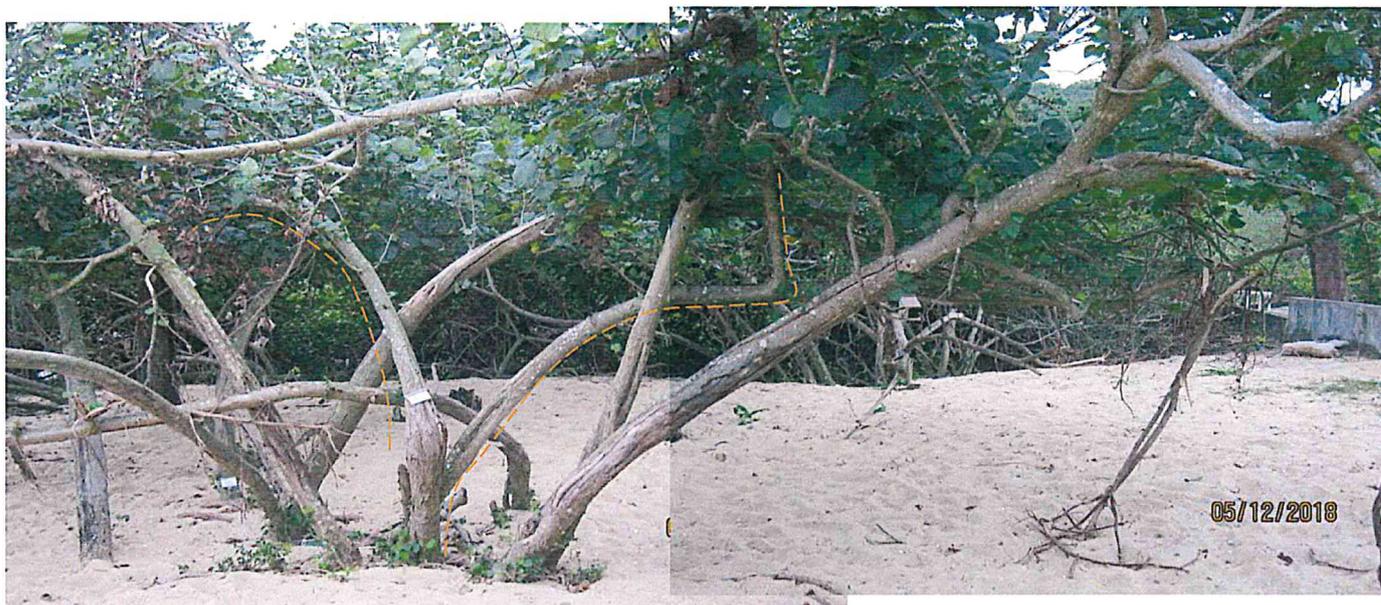
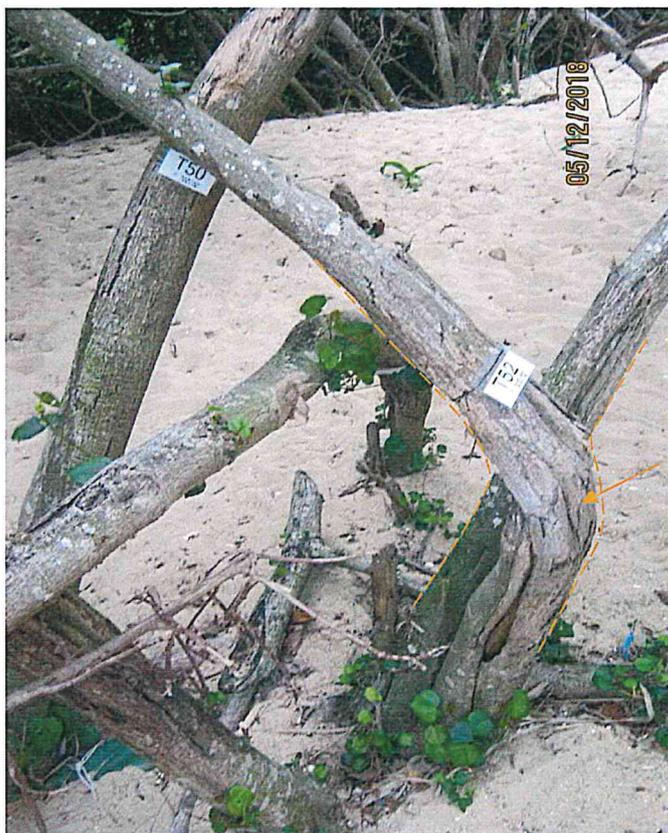
General View (Co-dominant stems in leaning form)

co-dominant stems in leaning form / a stem was distorted with cracks.

One of the stem distorted with cracks

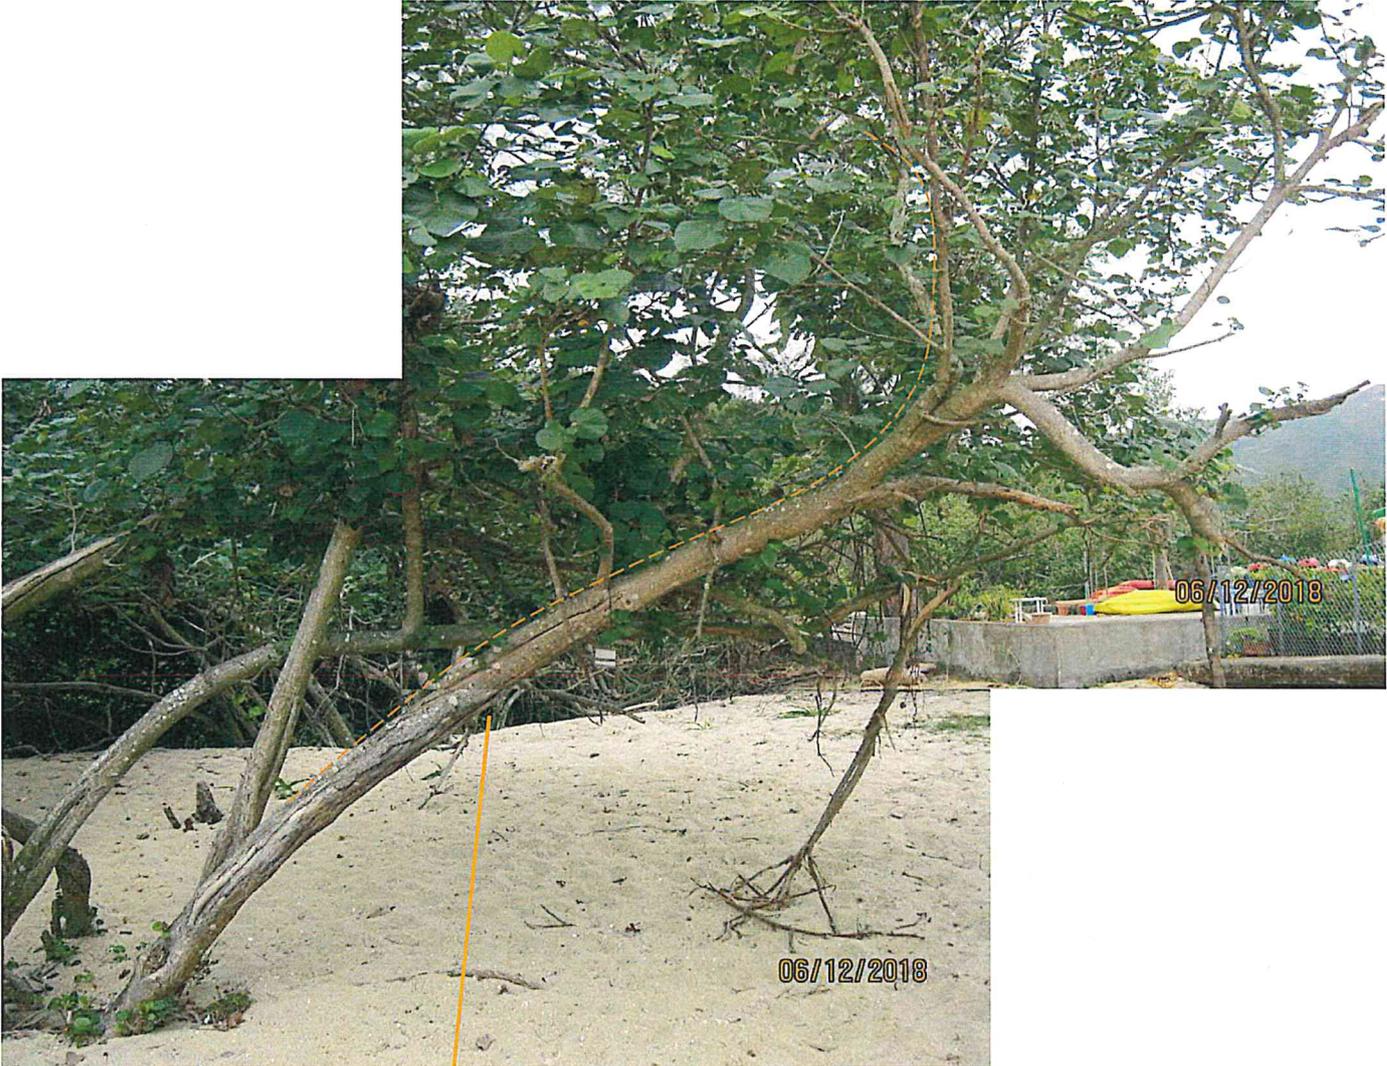
Tree No. T53 - *Hibiscus tiliaceus* 黃槿

tree in leaning form / crack at the trunk.

General View (leaning form)

crack at the trunk
