CONTRACT NO: HY/2019/14
NEW WANG TONG RIVER BRIDGE
BASELINE MONITORING REPORT

Highways Department

Lam Environmental Services Limited

24 May 2021

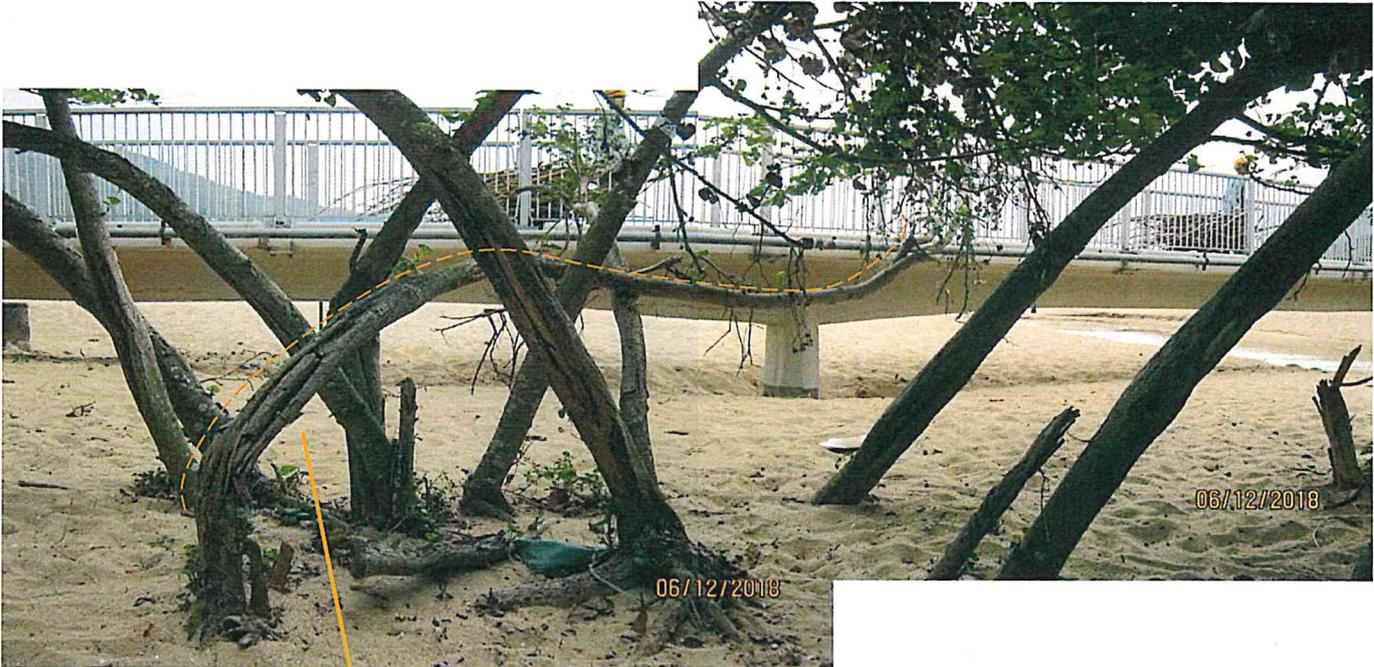
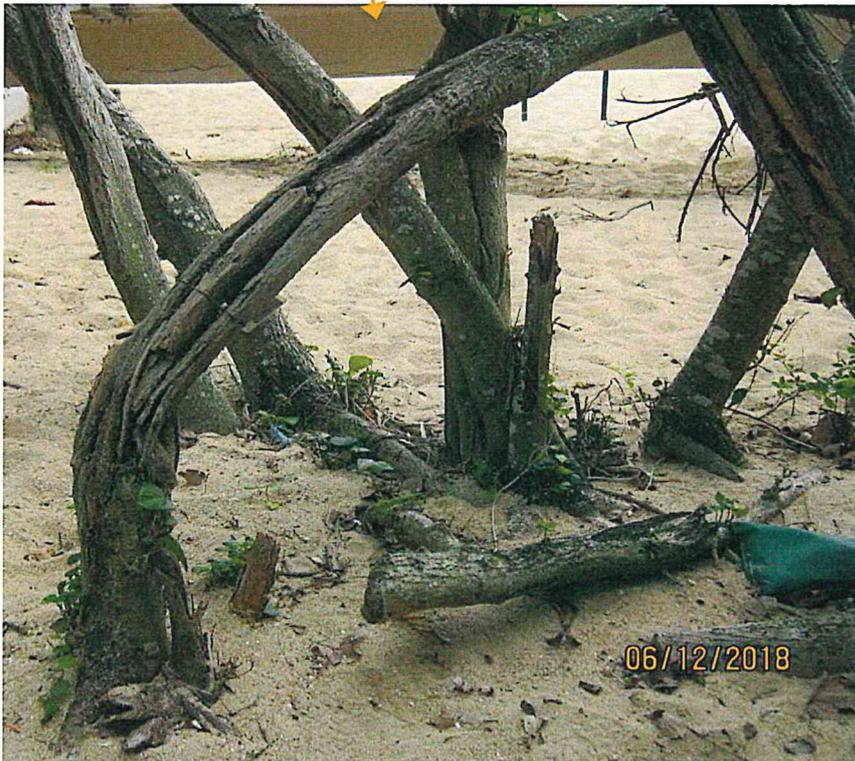
General View (leaning form)

tree in leaning form / distorted trunk with cracks.

distorted trunk with cracks
